BUNNELL'S POND DAM

NDI ID NO. PA-00170
DER ID NO. 64-29

PHASE I INSPECTION REPORT
NATIONAL DAM INSPECTION PROGRAM

MARCH 1981

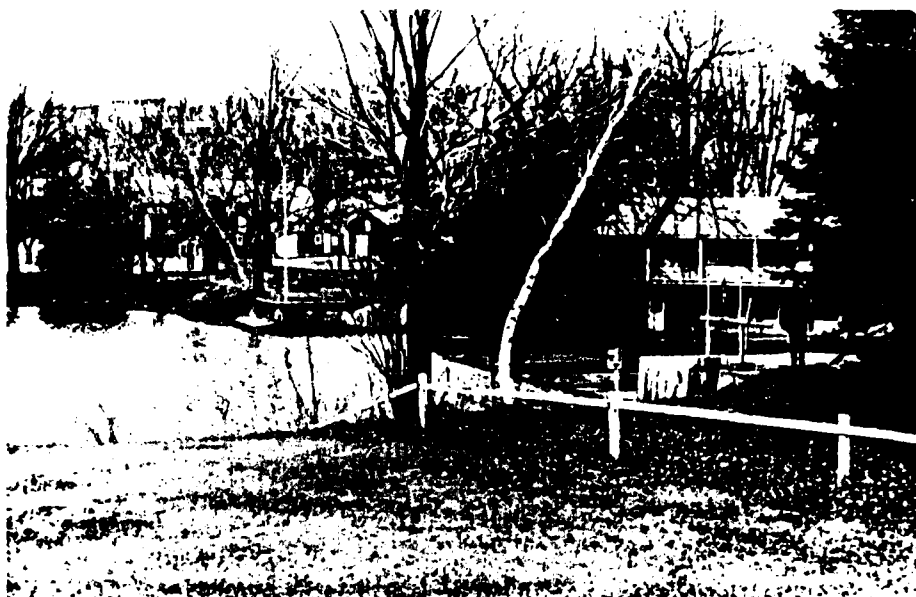
b. Embankment. The embankment is in generally fair condition. The upstream slope, protected with a stand of grass on the left end of the dam and with heavy stone on the right end, shows no signs of distress or erosion. The top of the earth portion of the dam is covered with a good stand of grass. A ten-foot section of the masonry wall on the downstream side of the dam to the left of the spillway is bulged outward approximately 6 inches. This condition was observed during inspections by the Commonwealth as early as 1930. The inspection reports also indicated that the condition seemed to have stabilized by 1937. By comparing the present condition with that shown in photographs taken in 1937, the bulging does not appear to have worsened during the intervening 44 years. Clear seepage was observed at the toe of the dam in the vicinity of the bulged area. The flow rate at the time of the inspection was estimated at 1/2 gallon per minute (gpm). The concrete cap on the top of the dam between the spillway and outlet works is spalled. The condition is superficial in nature and is not considered to affect the integrity of the dam.

A. Upstream Side of Dam

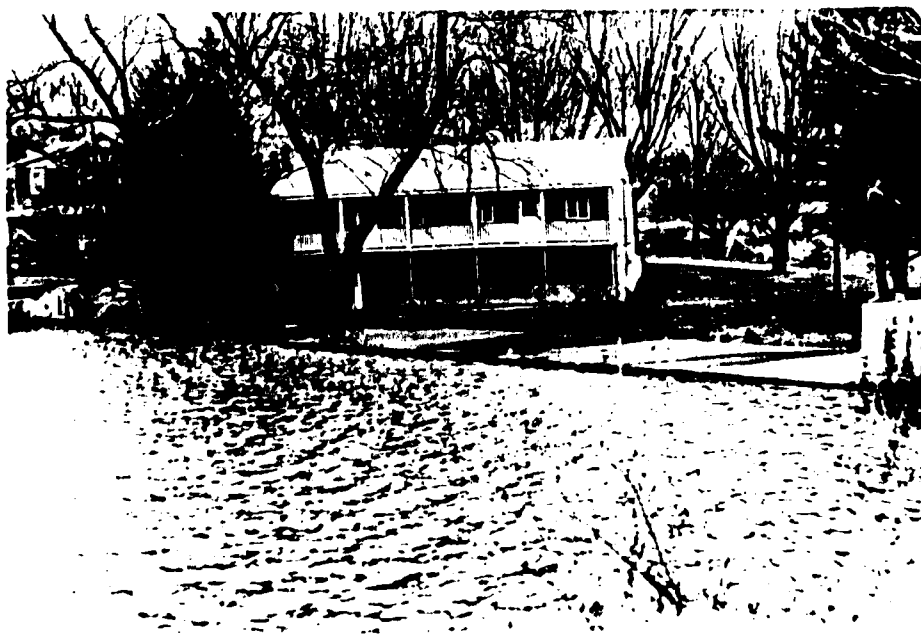
B. Upstream Side of Spillway
